Industrial Water

Cooling Tower

Case studies and analysis

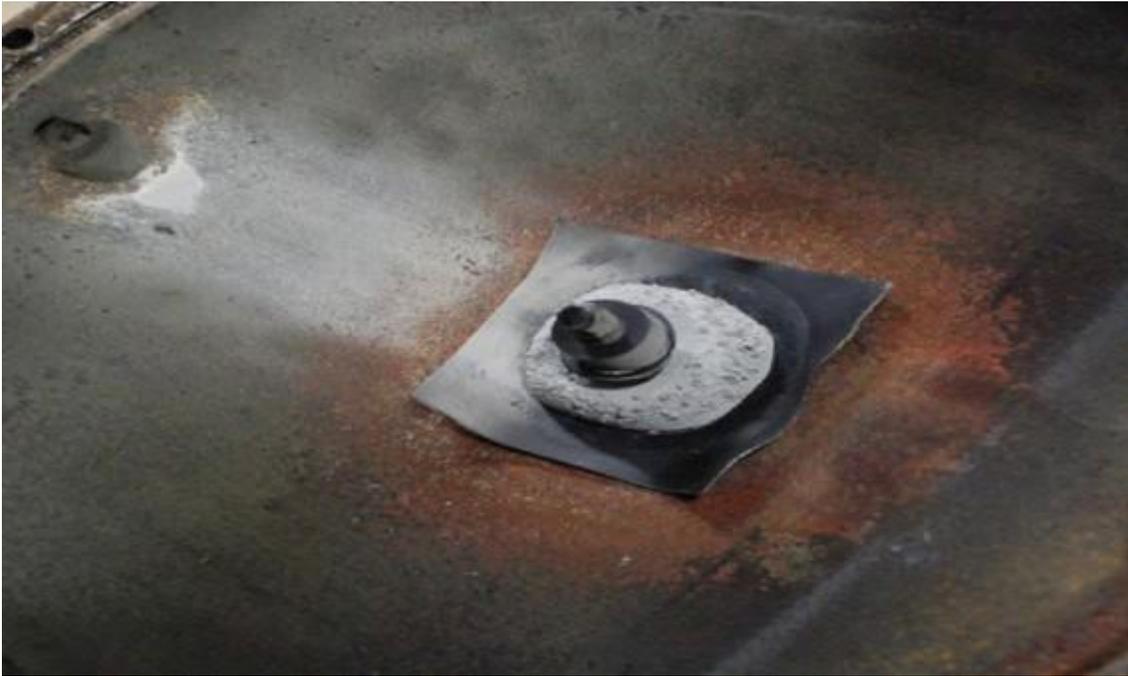
Chiller lid from phase one test facility after two cooling seasons on ProMoss™.

All treatments stayed the same except the blow-down setting was increased from 1800 to 3600 to see if the increased TDS would result in scale formation, corrosion or less efficient chemical control. No scaling occurred on the tower, there was a decrease in chemical consumption, and it took 0.5 hours to clean the tower the next year. The heat exchanger was scheduled for maintenance during the winter. There was no scaling or corrosion on the exchanger tubes and no cleaning was required.

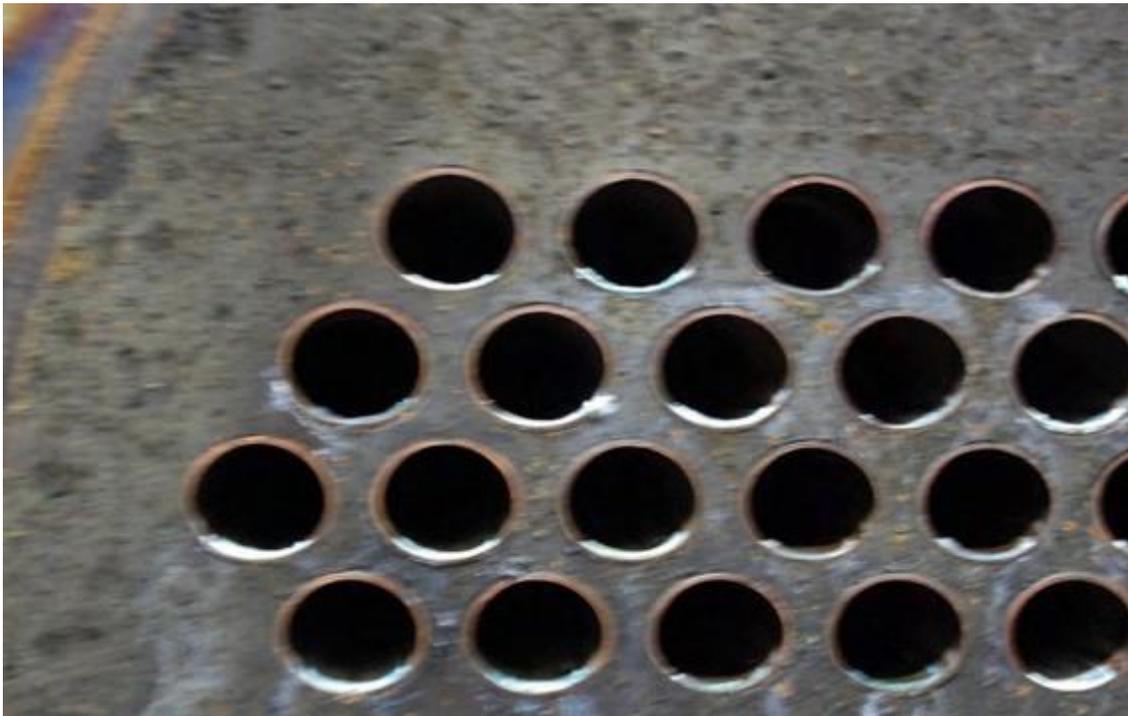
Chiller tubes from phase one test facility after two cooling seasons on ProMoss™

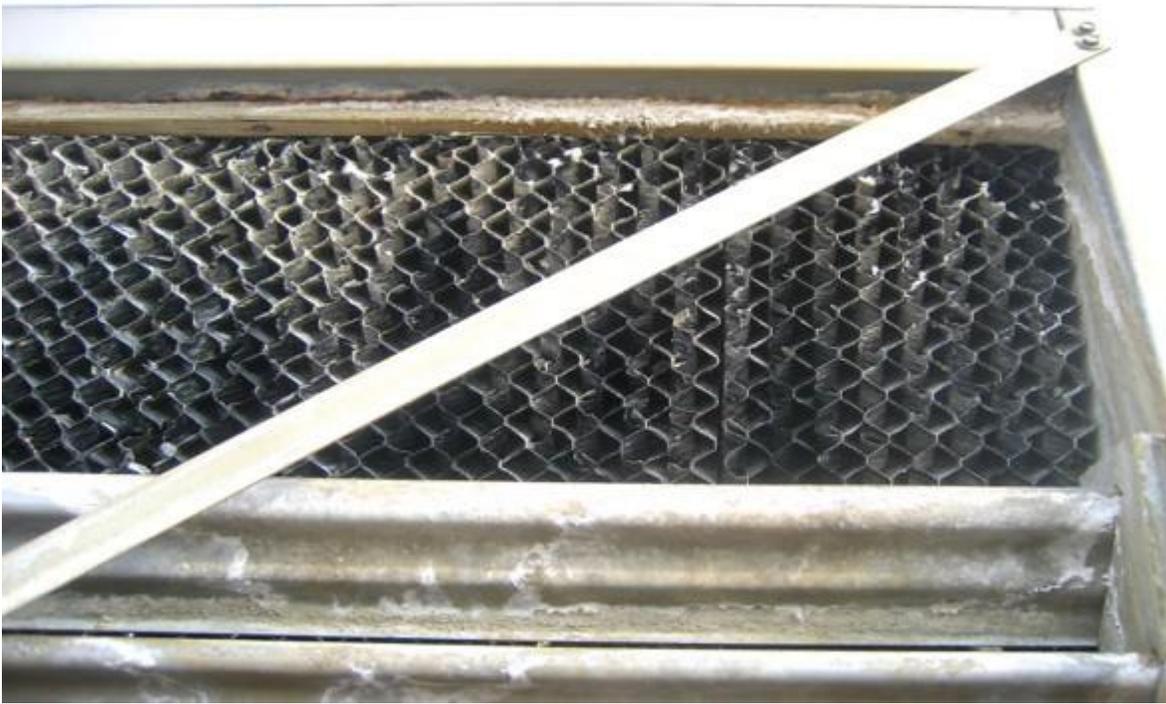
Cooling tower media from 16 year old phase one test facility before starting on ProMoss™

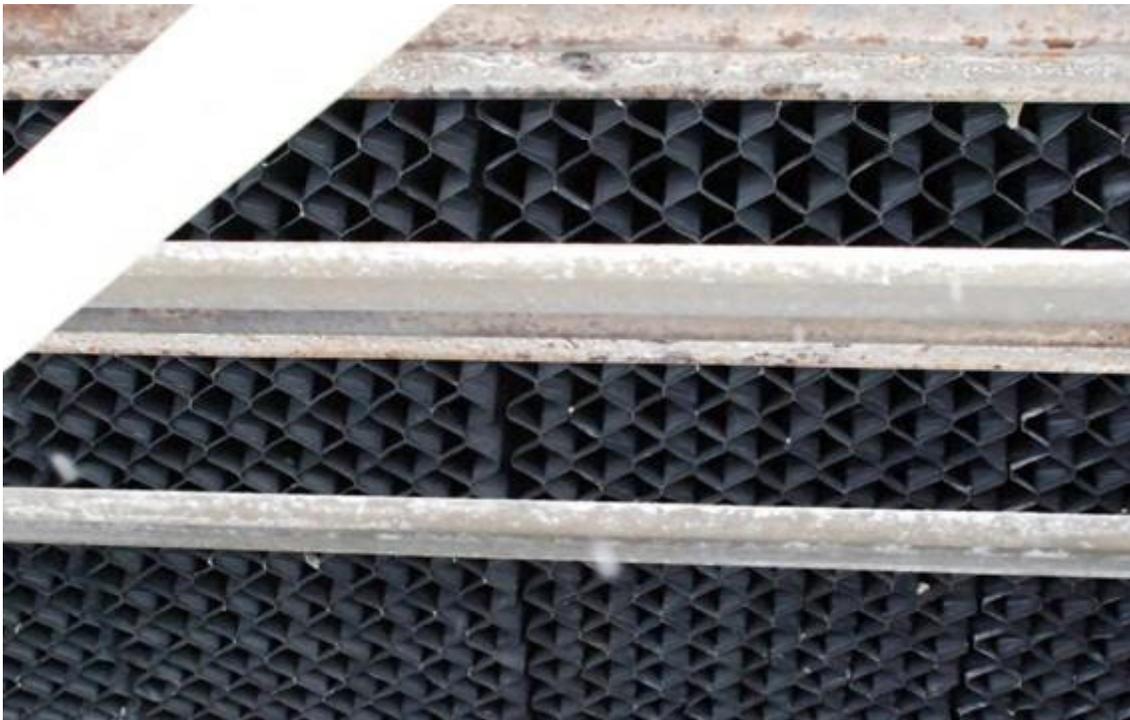
Cooling tower media from 16 year old phase one test facility after two cooling seasons on ProMoss™

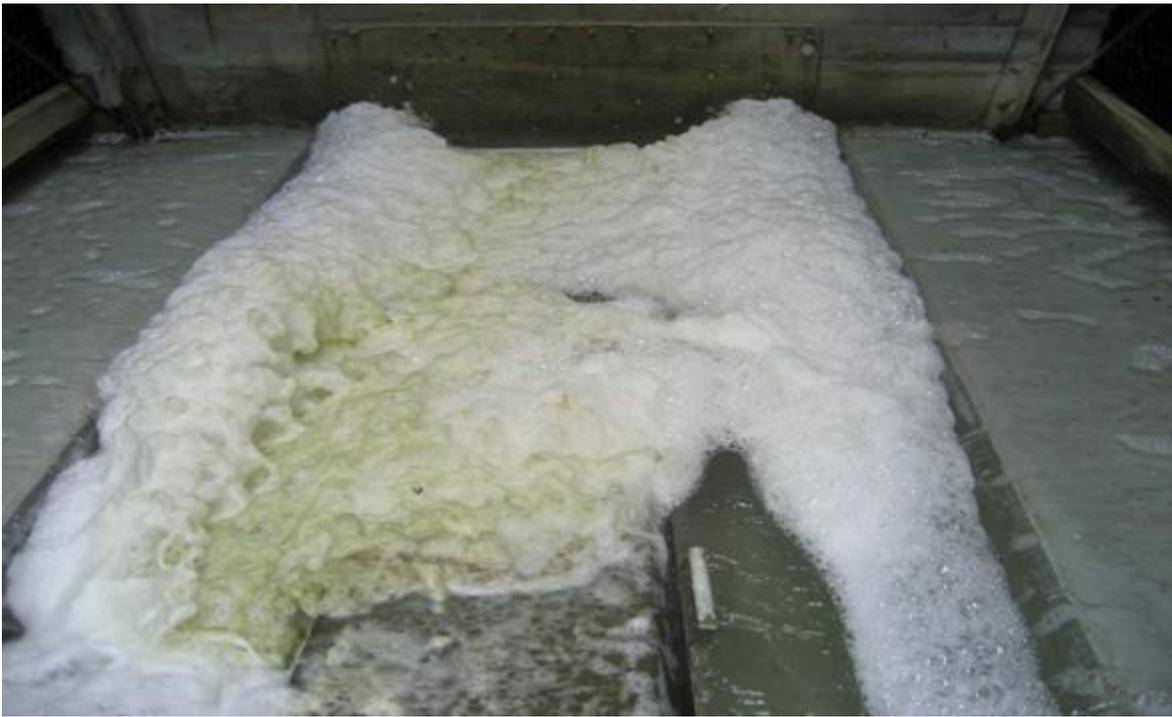
Water, foam, and organic contamination before starting on ProMoss™

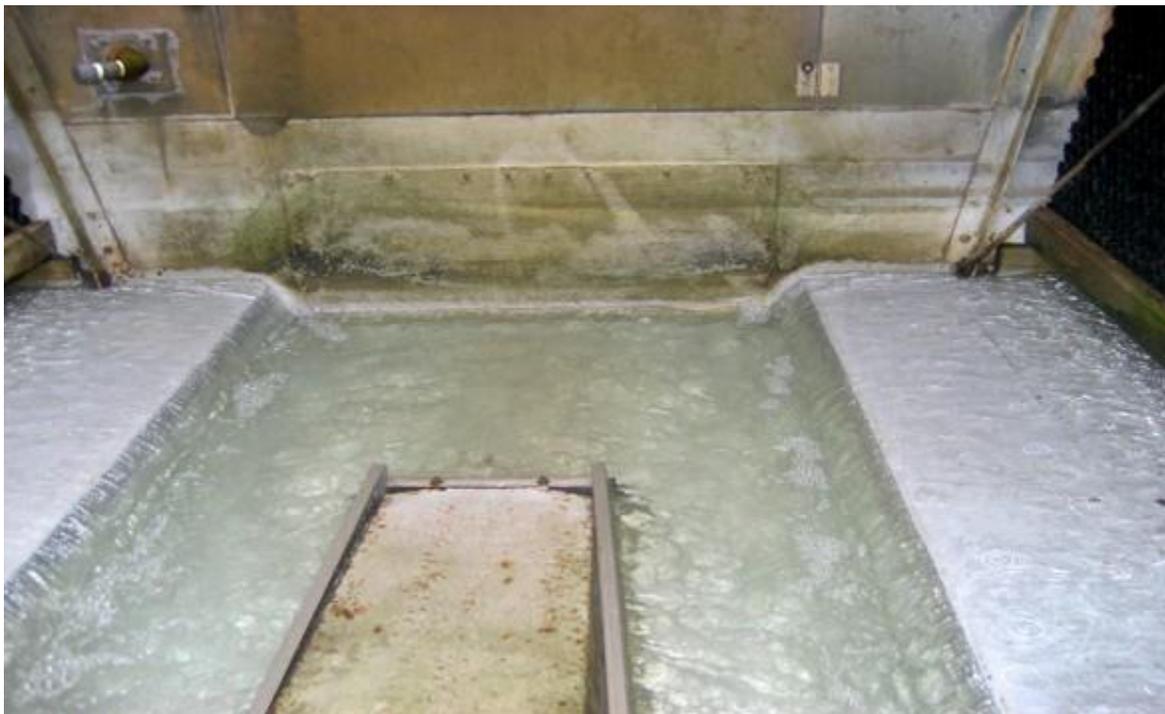
Water after two years treatment with ProMoss™ Note clarity, absence of foam and organic contamination

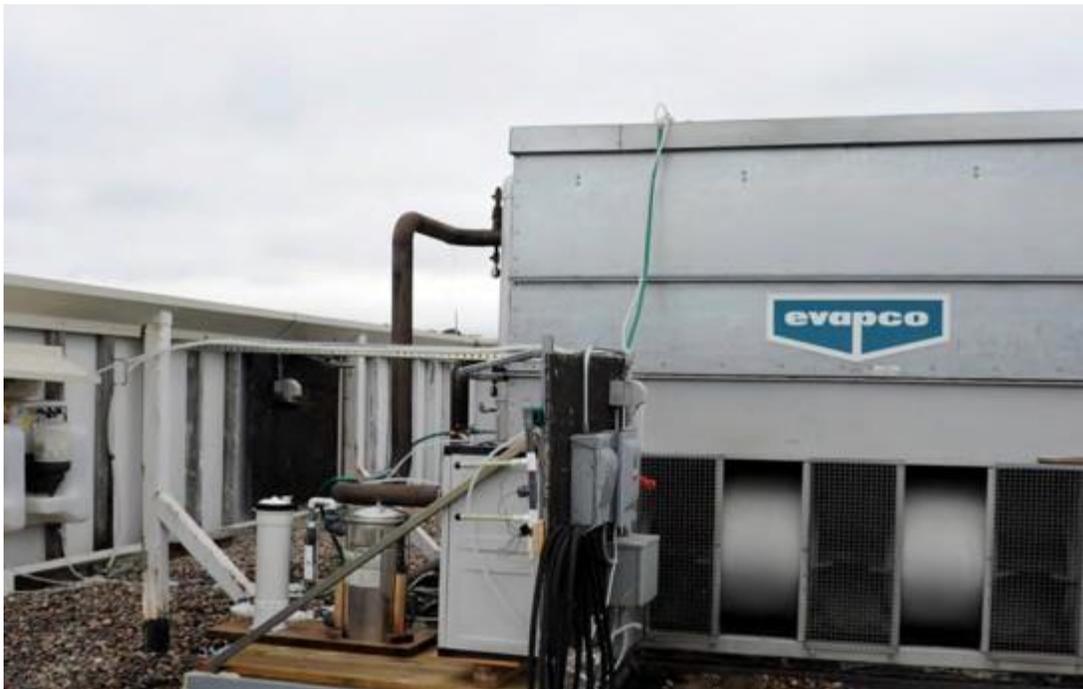
Sphagnum moss delivery system used on three different facilities. Stainless steel tank contains the Sphagnum moss, white PVC cylinder is a filter and two LPR probes are in line.

We contracted a local water treatment company, Jay Tech, to independently test three different facilities. They created a flow through system with a filter and separate contact chamber similar to the system used to deliver the Sphagnum moss to a residential pool (Figure 2). LPR probes for galvanized and soft steel were installed inline. Sphagnum moss treatment was started on July 14, biocide delivery remained unchanged, and corrosion, dispersant and scale inhibitors were stopped.

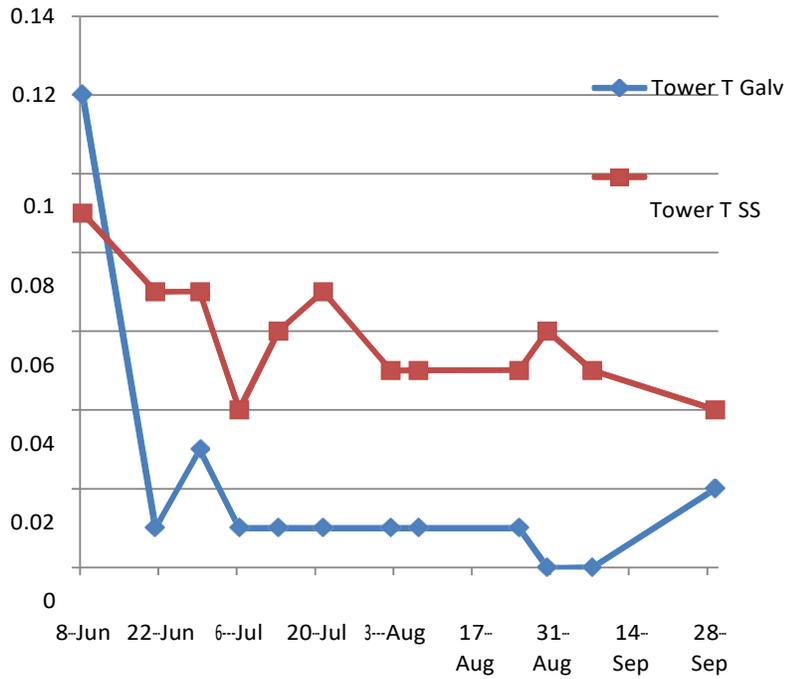
Corrosion values for Phase Two tower 1. Galvanized steel is in blue and soft steel in red. Dispersant and corrosion inhibitors removed on July 14.

We concluded that the measured corrosion was the same as or decreased when the corrosion inhibitor was discontinued on all three towers. The flows through systems had frequent fouling of the filters, were expensive, and were removed. We decided to return to the contact delivery cages in the basin of the towers for the next studies.

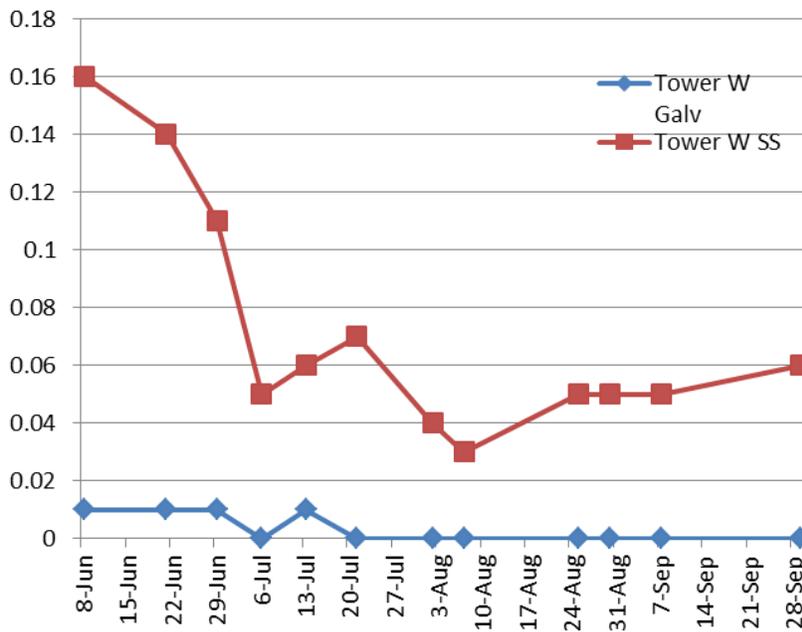
Corrosion values for Phase Two tower 2. Galvanized steel is in blue and soft steel in red. Dispersant and corrosion inhibitors removed on July 14.

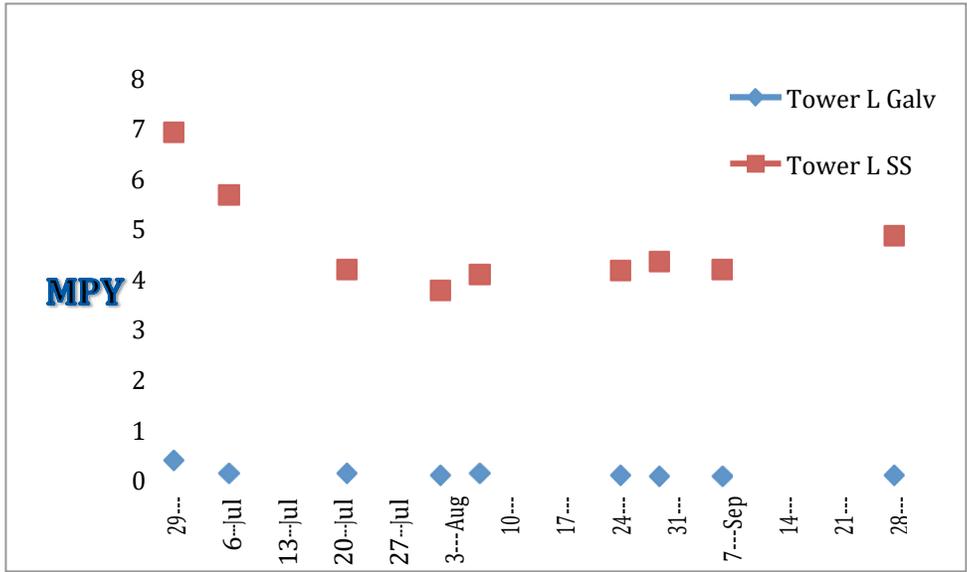
Corrosion values for Phase Two tower 3

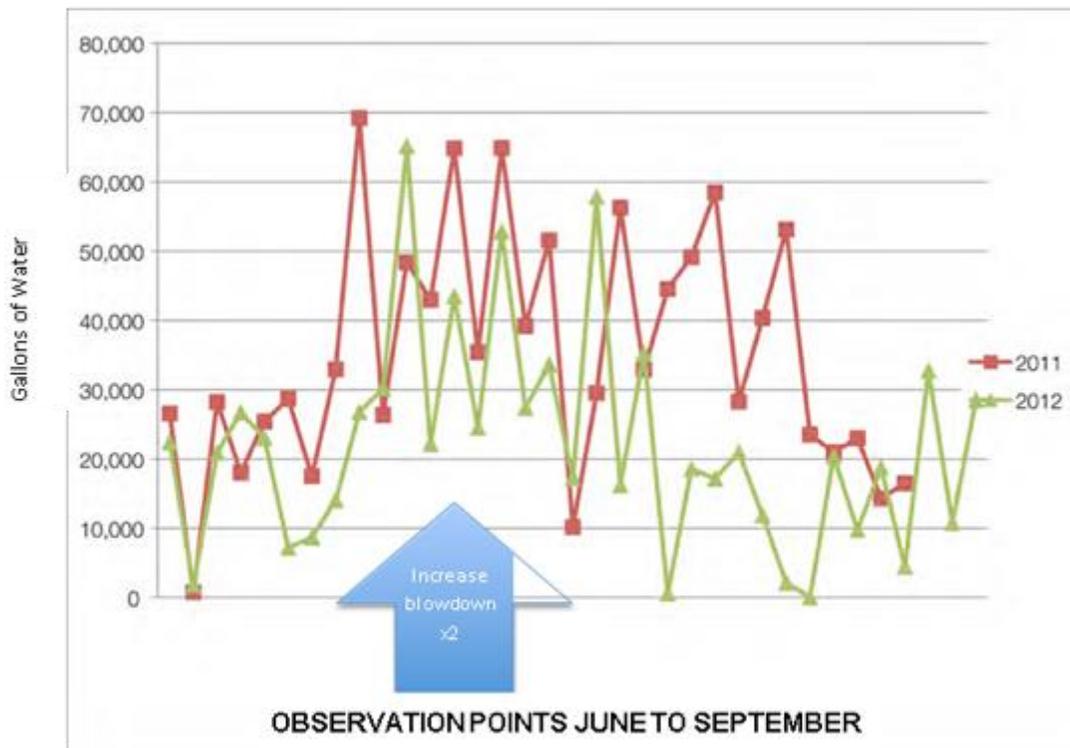
Water use comparison from Phase Three. Red is water used in 2011 with no Sphagnum moss and green is water used in 2012 with Sphagnum moss. Blue arrow is when blow-down setting is increased from 1800 to 3600 in tower 3. Temperature means for both years are similar

Corrosion for galvanized remained below 0.6 mpy on tower #4 after the corrosion inhibitor was removed, and below 0.7 mpy on tower #3 after the blow-down was doubled on tower #3. Water use decreased by 42% on tower #3 after the blow-down was doubled. All dip slides for bacteria were negative, and scaling was observed to decrease on both towers.

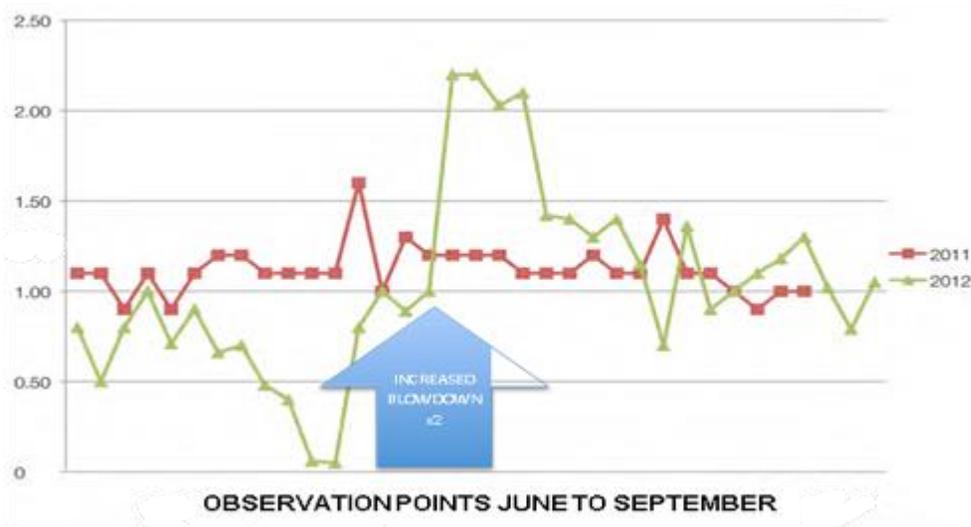
Corrosion inhibitor concentration comparison from Phase Three. Blue arrow is when blow-down settings were increased from 1800 to 3600

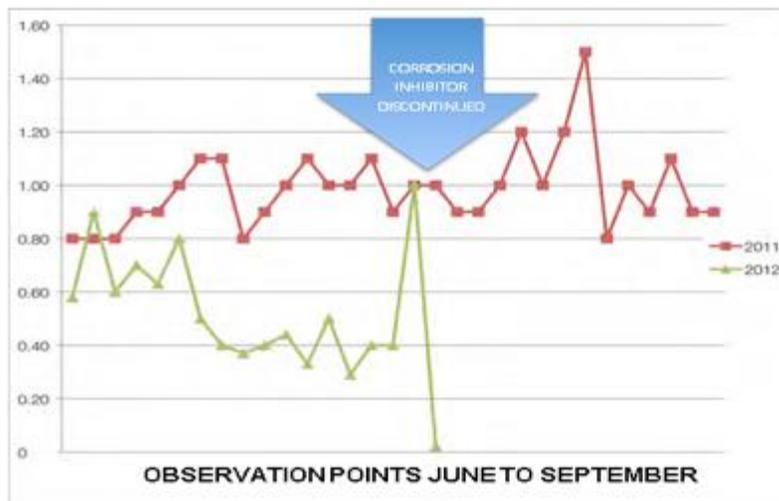
Corrosion inhibitor concentration from Phase Three tower 4. The blue arrow indicates when corrosion inhibitor feed was discontinued. Corrosion for galvanized steel was 0.09 mpy with corrosion inhibitor and Sphagnum moss and 0.55 mpy when corrosion inhibitor was discontinued.

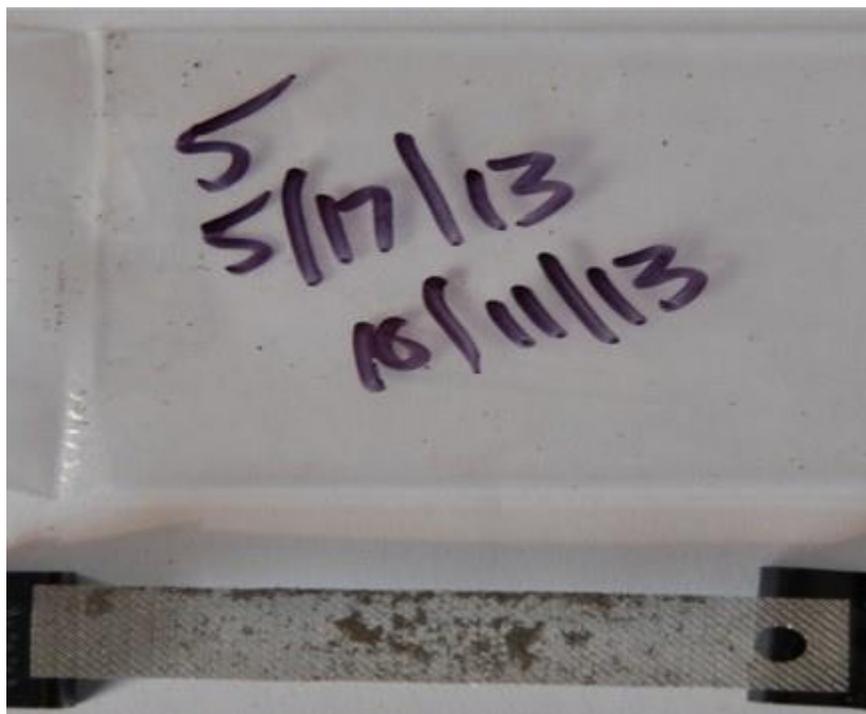
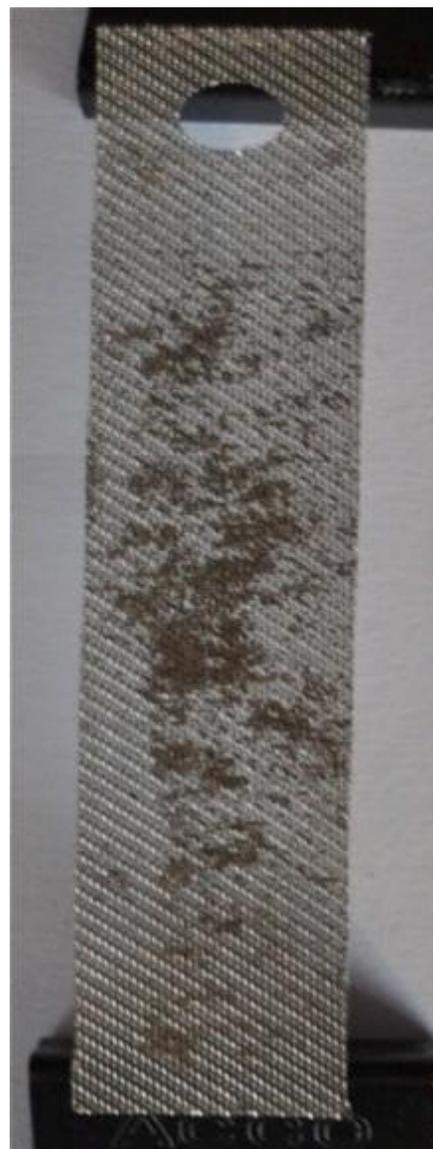
ORGANIC CONTAMINATION ACCUMULATION

Control Cooling Tower without ProMoss™

Water was treated with two biocides, a dispersant
and corrosion inhibitor.

The same two towers as in year one were treated with Sphagnum moss and a third ,650 ton, tower was used as a control. We measured corrosion for copper with both coupons and probes, and measured organic contamination formation using special mesh coupons. All three towers were treated with two biocides, corrosion inhibitor and dispersant.

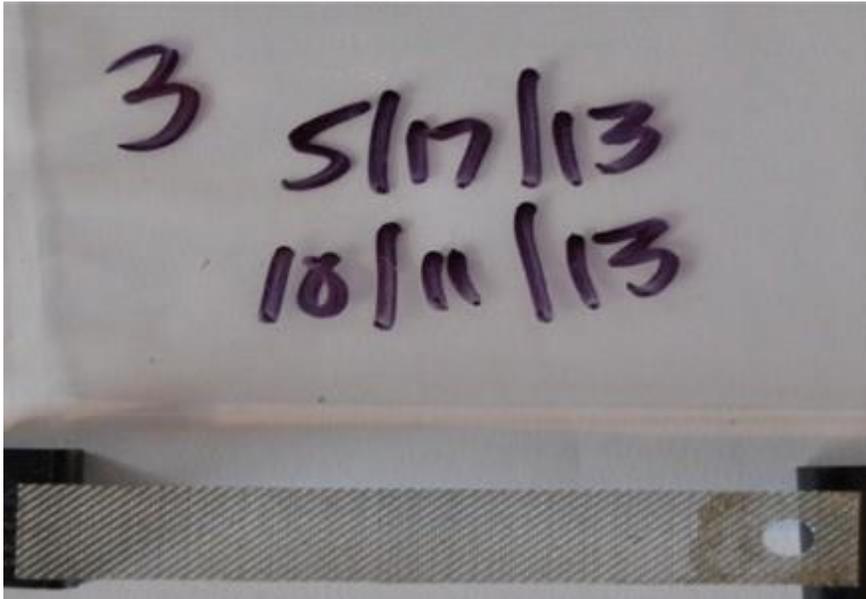
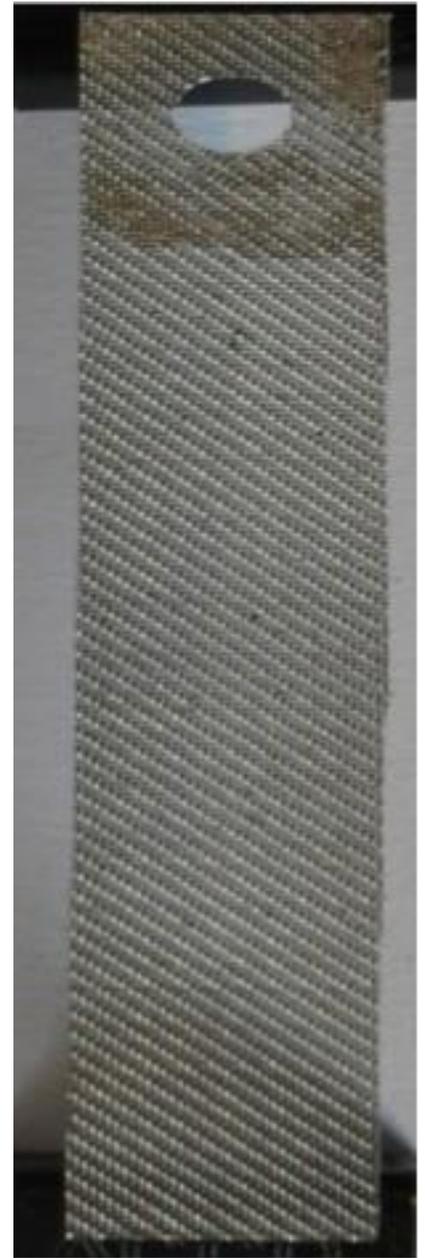
ORGANIC CONTAMINATION ACCUMULATION

Cooling Tower with Sphagnum Moss in addition
to two biocides, a dispersant
and corrosion inhibitor.

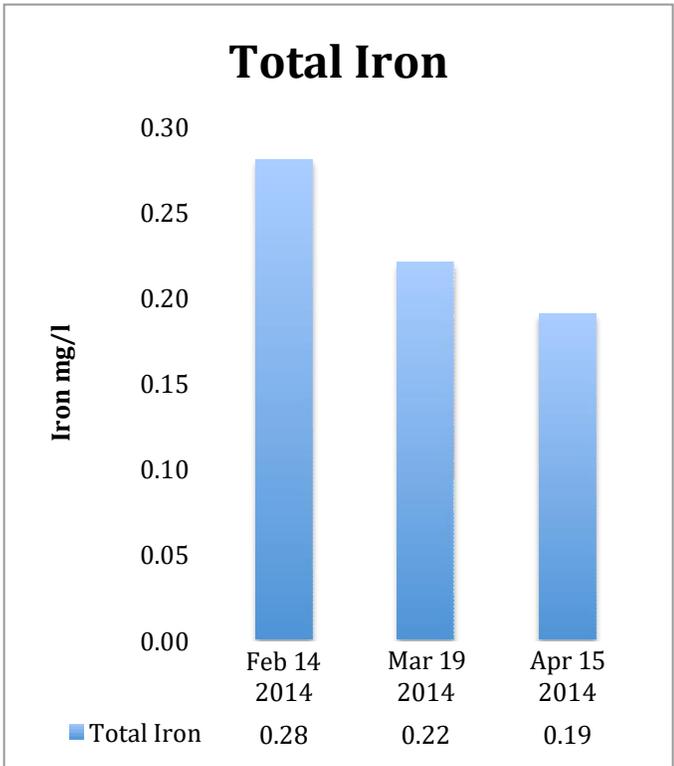
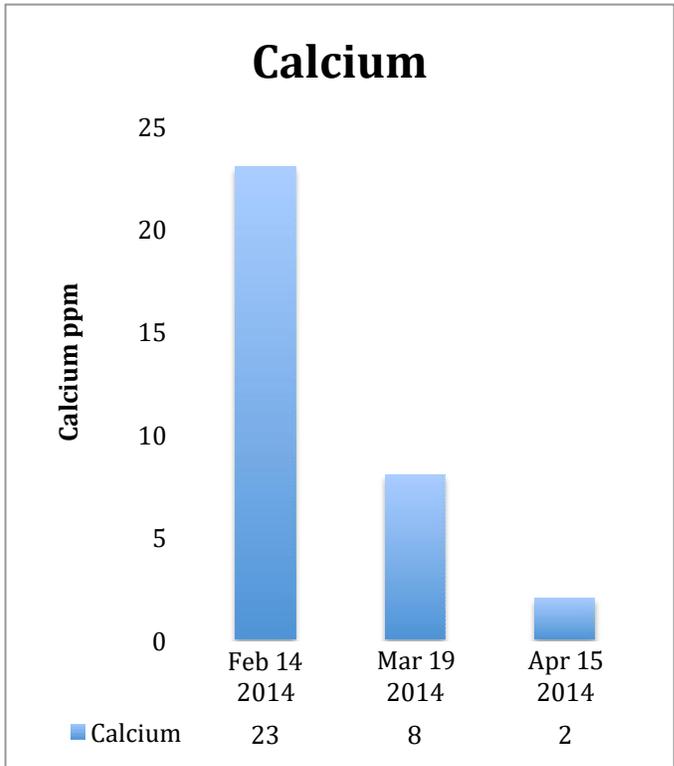
Pre treatment with ProMoss™

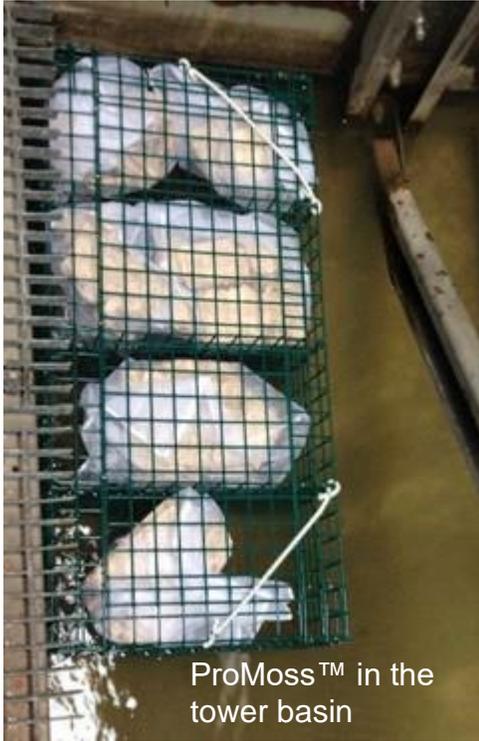
ProMoss™ in the tower basin

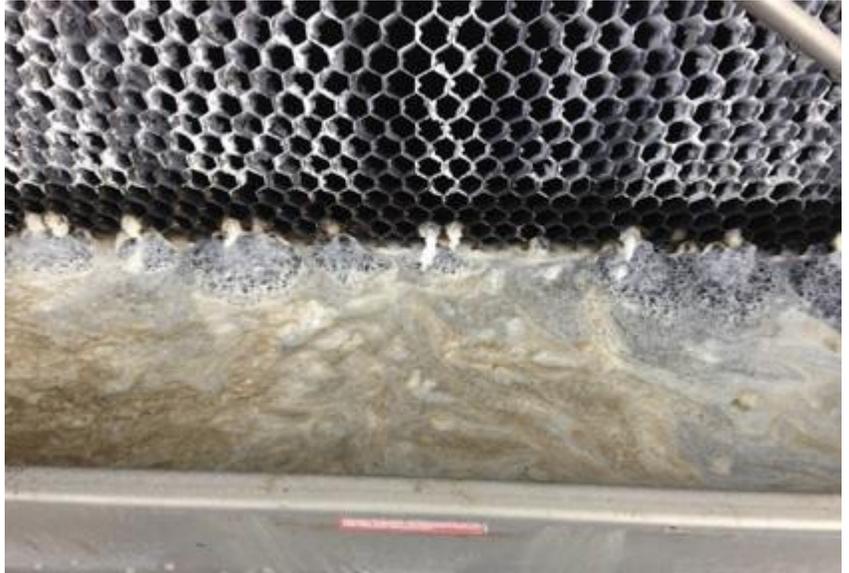
Foaming in return water (note foam coming from the media)

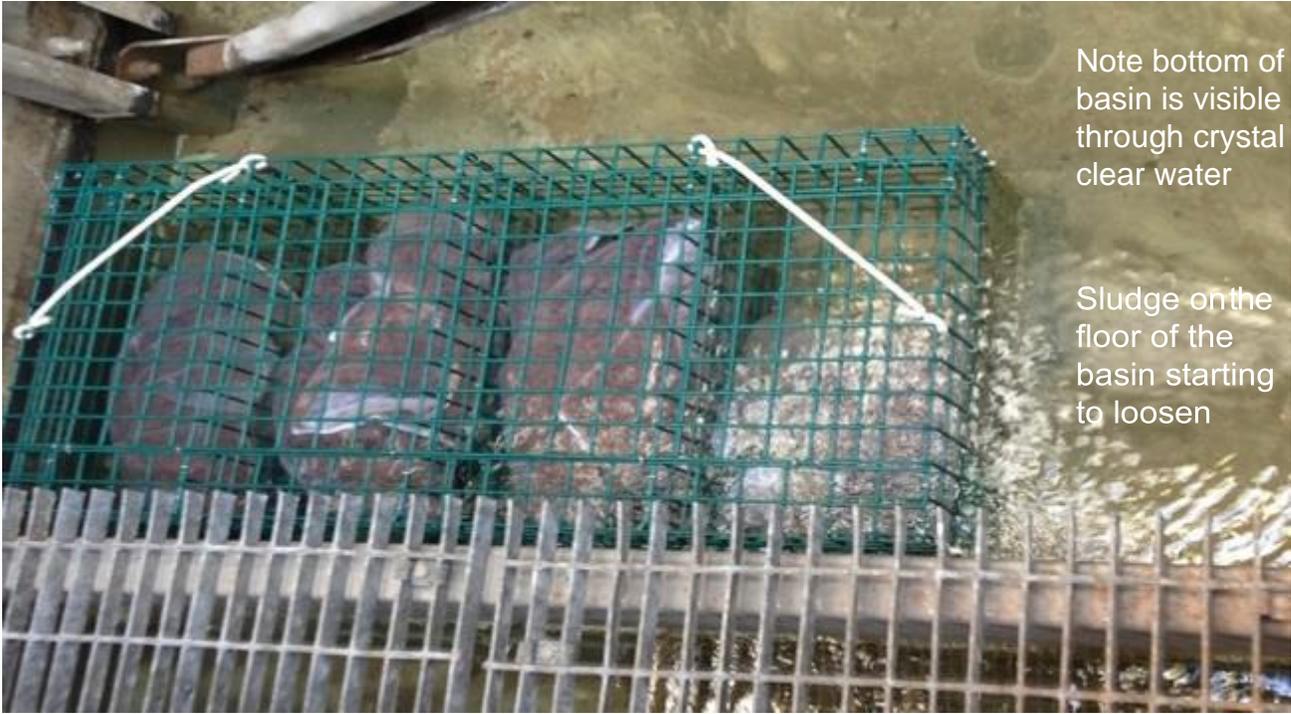
Two Months treatment with ProMoss™

Note bottom of basin is visible through crystal clear water

Sludge on the floor of the basin starting to loosen

Treatment with ProMoss™ for two months resulted in significant improvements in water clarity, decrease in foaming, scale removal from the areas in contact with the water, and reductions in iron and calcium ion concentration with no change in the water treatment regimen.
